Ushapivsky I.L. Experimental studies of vibrations centrifugal fire pump with defective bearings

Abstract. The work deals with an experimental study of vibrations of centrifugal fire pump PN-40UV with defect. A worn-out bearing assembly was selected as internal defect. The vibration accelerations signals have been analyzed by their spectral structure. It was determined that the presence of the worn bearing in the pump leads to an appearance of additional harmonics with specific frequencies. This harmonics arises in the most dynamically loaded regime of operation - the usage of a pump filled with a water but without its filing. These vibrational symptoms of the analyzed type of hidden defects could be used in the procedures of fire pumps technical diagnostics.

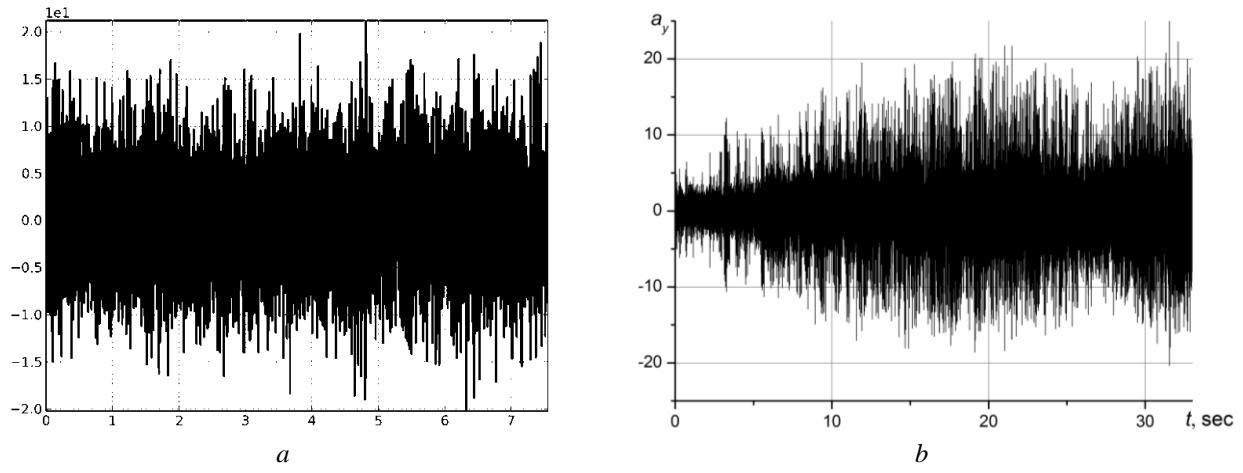
Fig. 2a presents an obtained vibrational acceleration in the vertical direction in the measurement point. A presence of the random fluctuations and polyharmonic nature in the signal could be observed.

Analogous tests with the over values of pump rotor angular velocities have been carried out to obtain more detailed information about the vibrational processes (Fig. 2b). Generalization of these results can be obtained by special tests, when vibrational signal is analyzed during continuous gradual increasing of the frequency of excitation. So, the test was made with the pump, that operates with the angular velocity, which is gradually increased from 800 rpm to 2100 rpm.

Fig. 2. A typical obtained signals during the tests of fire pump vibration a – recorded vibration acceleration signal; b - the test of the pump vibration with the continuous gradual increasing of the frequency of excitation

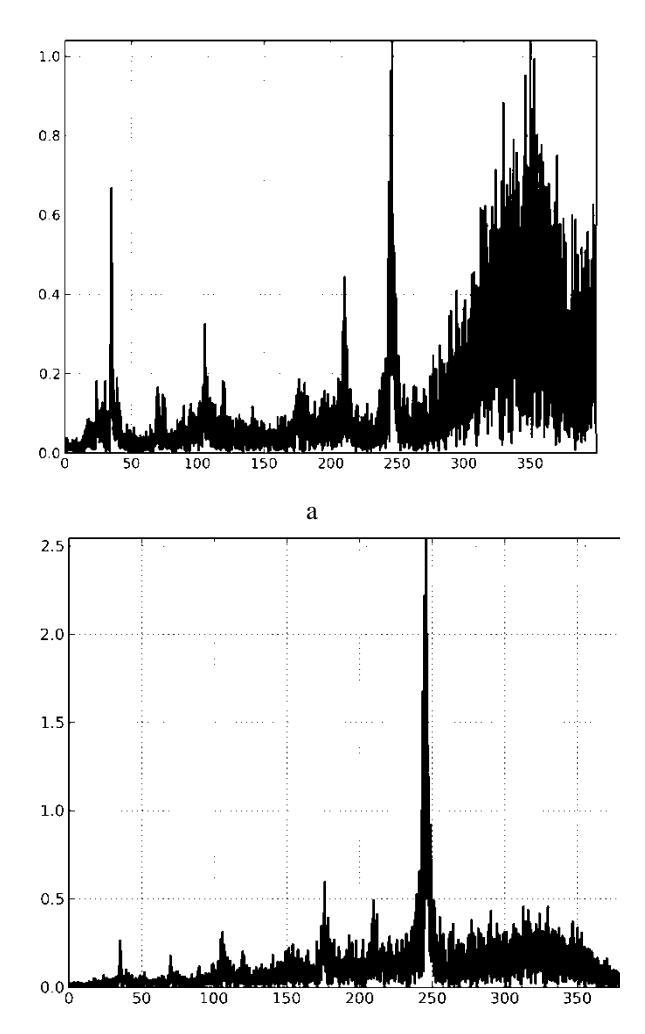
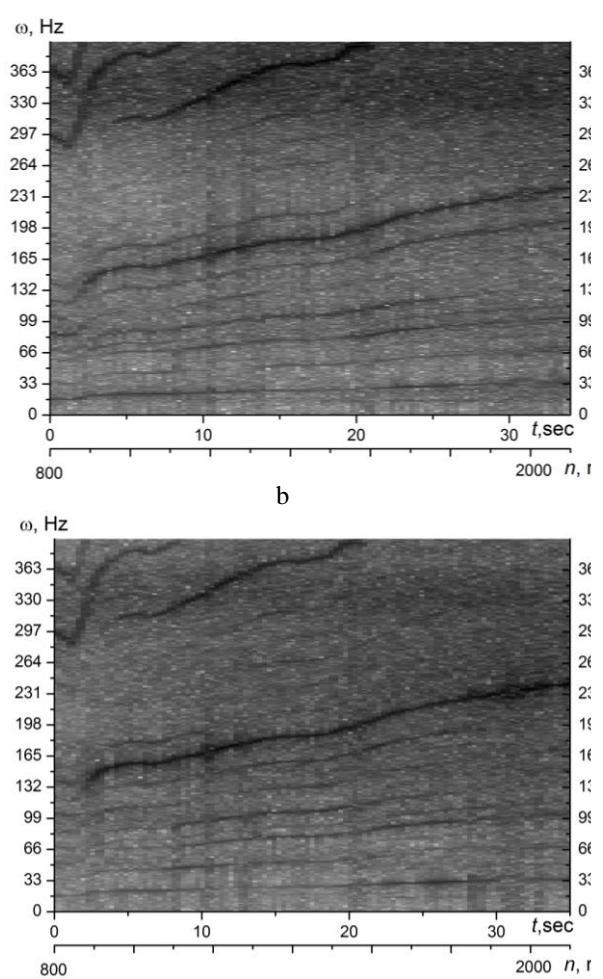
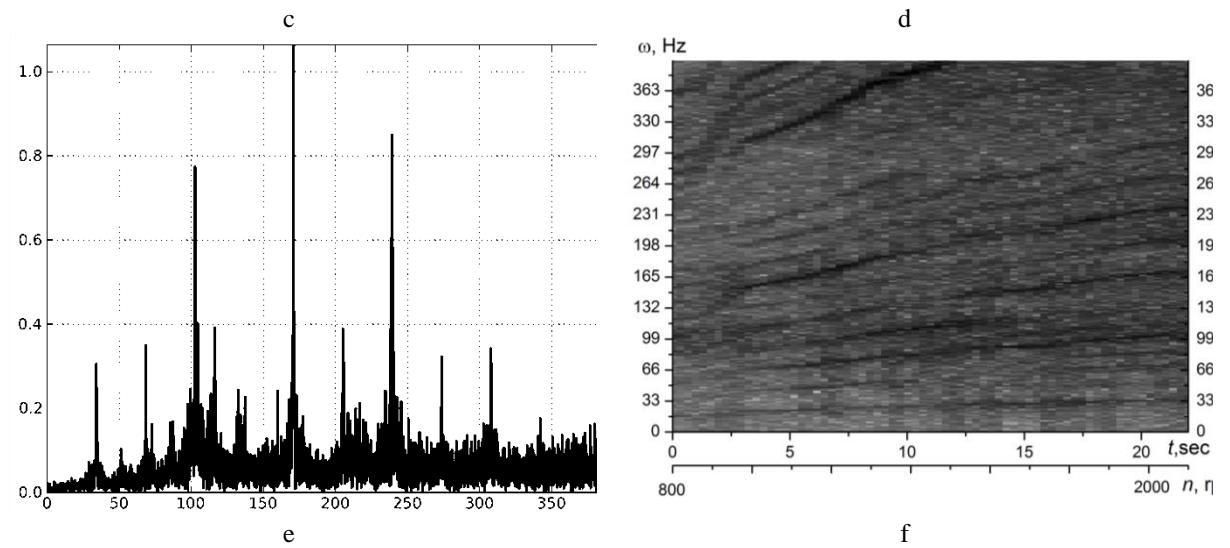
Vibration analysis shows a wide spectrum of harmonics. It is 1, 2, 3, 5, 6 and 7 harmonics and resonance mode is also observed in the range 300-400 Hz. The largest amplitudes are 1, 7. Existence and domination of 7 harmonic are associated with turbulent flows in the chamber of the pump that forms near the edges driven wheel blades. The pump driven wheel has 7 blades.

The presence of harmonics with a frequency of about 120 Hz is an important observation. The spectrum also has a harmonic with a frequency close to 0.5 from the main rotor angular velocity. Identified the frequencies of vibrations are confirmed by the pattern of the spectrogram, where frequencies of 0.5 and (3.5 - 3.6) of the main harmonic are observed at the almost of the full range.

Fig. 6. Spectrums (a, c, e) and spectrograms (b, d, f) of vibration accelerations of the fire pump, which has defect (worn-out bearing) in the vertical (a, b), the axial (c, d) and horizontal (e, f) directions

Vibration in the axial direction has a less amplitudes of harmonics in the spectrum and 7th harmonic is completely dominates. The harmonic with frequency around (116-120) Hz is also present in the spectrum. Spectrogram confirms made observations. Vibrations in the horizontal direction is close to the pattern of vibrations in the vertical direction so all the harmonics from 1 to 8 are excited. The largest amplitude has 5 harmonic. The harmonic with a frequency of 116 Hz is also excited.

So, vibrations of the pump with worn-out bearings characterized by the presence of the harmonic with frequency about 120 - 116 Hz, which corresponding to frequencies that characterize the presence of damage in the inner bearing cage or separator.
