Ushapivsky I.L. Experimental studies of vibrations centrifugal fire pump with defective bearings

Abstract. The work deals with an experimental study of vibrations of centrifugal fire pump PN-40UV with defect. A worn-out bearing assembly was selected as internal defect. The vibration accelerations signals have been analyzed by their spectral structure. It was determined that the presence of the worn bearing in the pump leads to an appearance of additional harmonics with specific frequencies. This harmonics arises in the most dynamically loaded regime of operation - the usage of a pump filled with a water but without its filing. These vibrational symptoms of the analyzed type of hidden defects could be used in the procedures of fire pumps technical diagnostics.

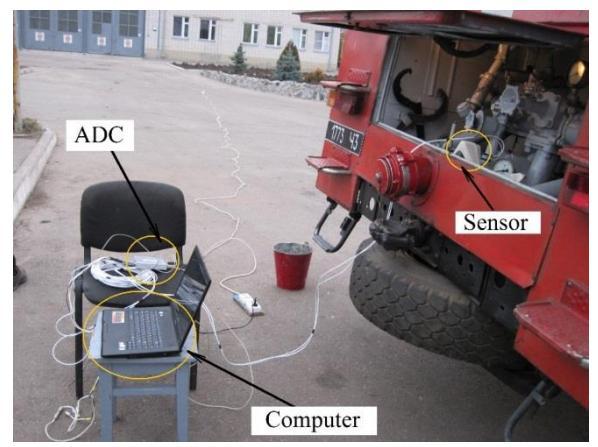
Experiment conditions and facilities. In the work, the experimental tests have been done with the centrifugal pump, which has been installed on an active fire engine. Experiments were carried out on the base of a measurement system "Ultra-V-I" [1,2], which has been developed at the Department of the Dynamics and Strength of Machines of the National Technical University "Kharkiv Polytechnic Institute" (Kharkiv, Ukraine). The measuring system consists of (fig. 1): a detector of vibration accelerations, an analogue-to-digital converter (ADC) and a portable computer. "Ultra-V-I" has a valid certificate of state metrological certification and allows to make a measurement of vibration acceleration at the point of investigated object. Some details of experiments study facilities are presented in the paper [3]. The measurements have been carried out on the body of a suction pipe of the fire pump (fig. 1).

Fig. 1. Measurement system "Ultra-V-I" during the firepump vibration tests
